# Navajo Abandoned Uranium Mine

# Site Screen Report

Mine Name: Blk029

Mine ID: 406

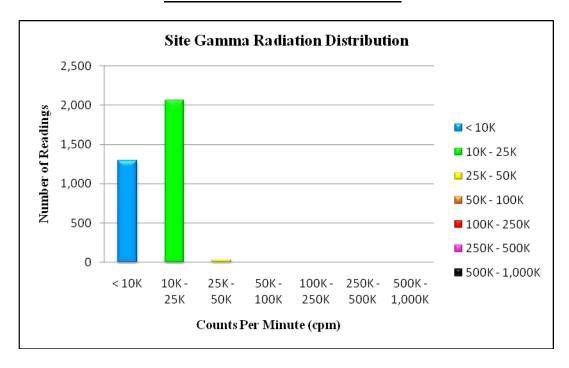
**Highest gamma radiation measurement:** 38,073 counts per minute (cpm)

**Background Average:** 13,204 cpm **Two Times Background:** 26,407 cpm

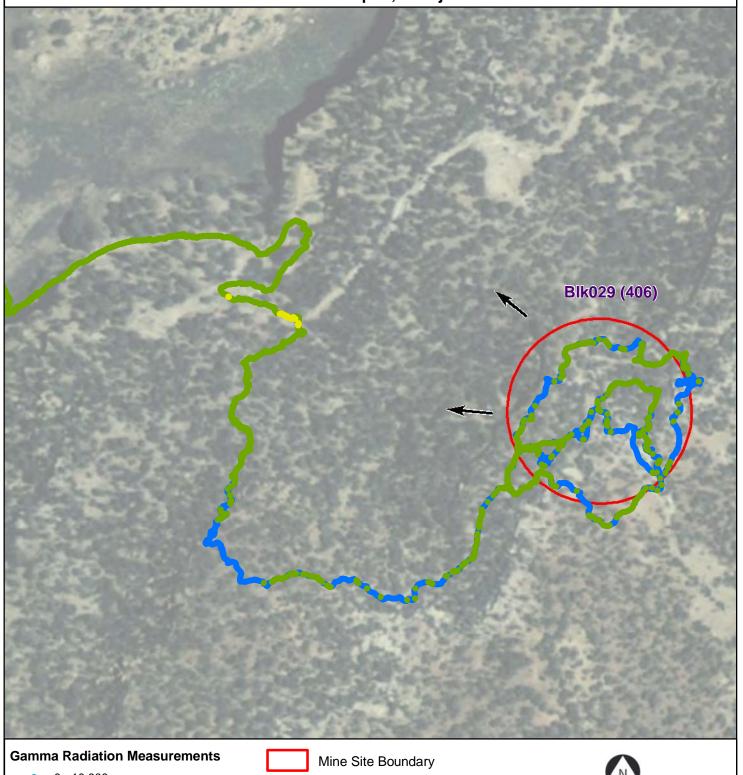
Figure 1 - Gamma Radiation Measurements, Above Two Times Background
Blk029 (406)
Black Mesa, Navajo Nation

A total of 3,390 gamma radiation measurements were collected from the mine site, ranging from 5,359 cpm to 38,073 cpm. The measurements are represented in Figures 1 and 2.
